SINGLE DEFECT REPORT

NOT FOR DISTRIBUTION
SAMPLE REPORT ONLY
THIS REPORT IS INTENDED
AS AN EXAMPLE OF THE
TYPE
OF INFORMATION THAT
WILL BE INCLUDED

SURVEY DATE 14 Sep 2022

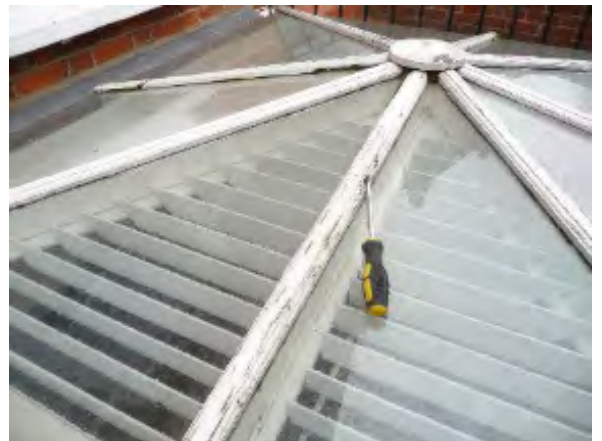
4. Rotten frame to lantern

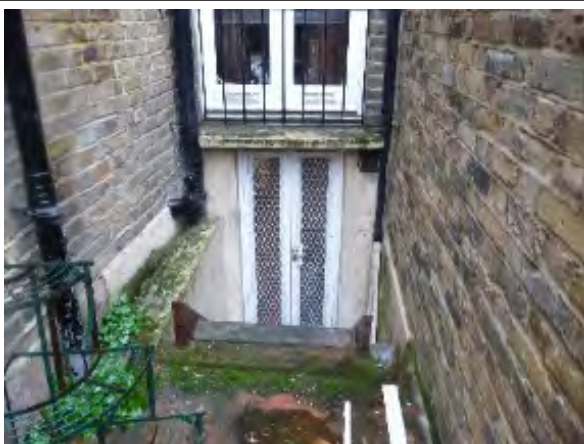
5. Subterranean rear doors - area very wet

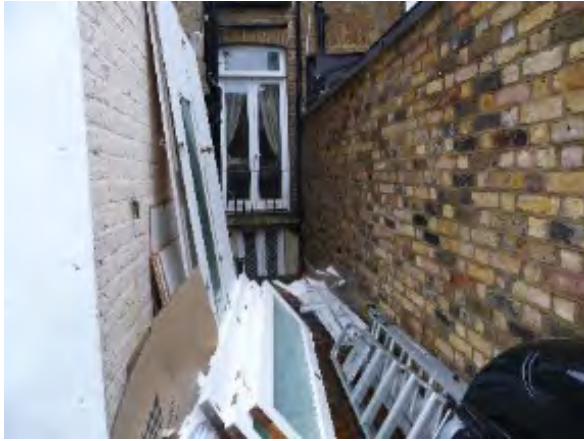
7. Discarded materials around rear

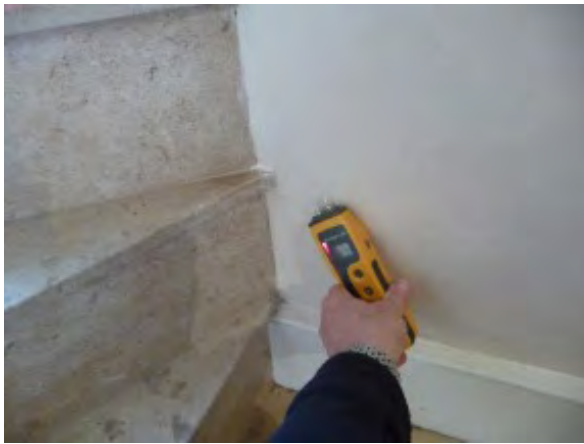
9. Dampness on internal wall by stairs

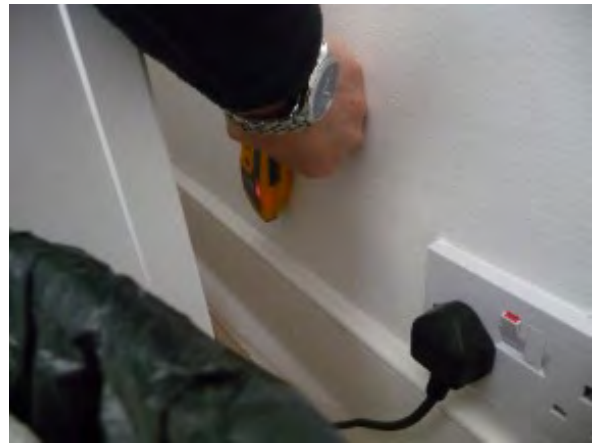
10. Dampness on internal wall

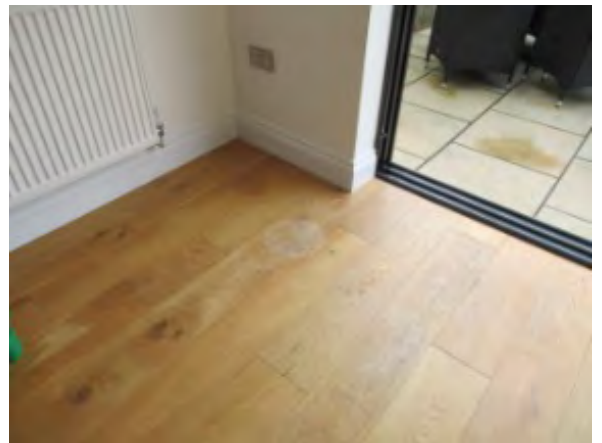
12. Dining room floor

<p>Conclusion</p>	<p>It was noted that a water supply pipe to the external tap on the outside wall of the dining room is likely to be embedded in the floor of the dining room. The very localised nature of the dampness being experienced suggests that because is not a failure of the damp proof course, but more likely to be a leak from the water supply pipe which runs under the wall immediately beneath the area where dampness is being experienced.</p>
<p>Recommended actions</p>	<p>The floor of the dining room in the area between the external tap and the kitchen will need to be carefully excavated to reveal the water supply pipe believed to be concealed beneath. The assumed leak should be identified and repaired as necessary.</p>
